TECHNICAL REPORT GL-79-2

TRAFFIC TESTS OF EXPEDIENT AIRFIELD  
CONSTRUCTION CONCEPTS FOR POSSIBLE  
APPLICATION IN THE NATIONAL  
PETROLEUM RESERVE ALASKA (NPRA)

by  
Carl D. Barnes

March 1979

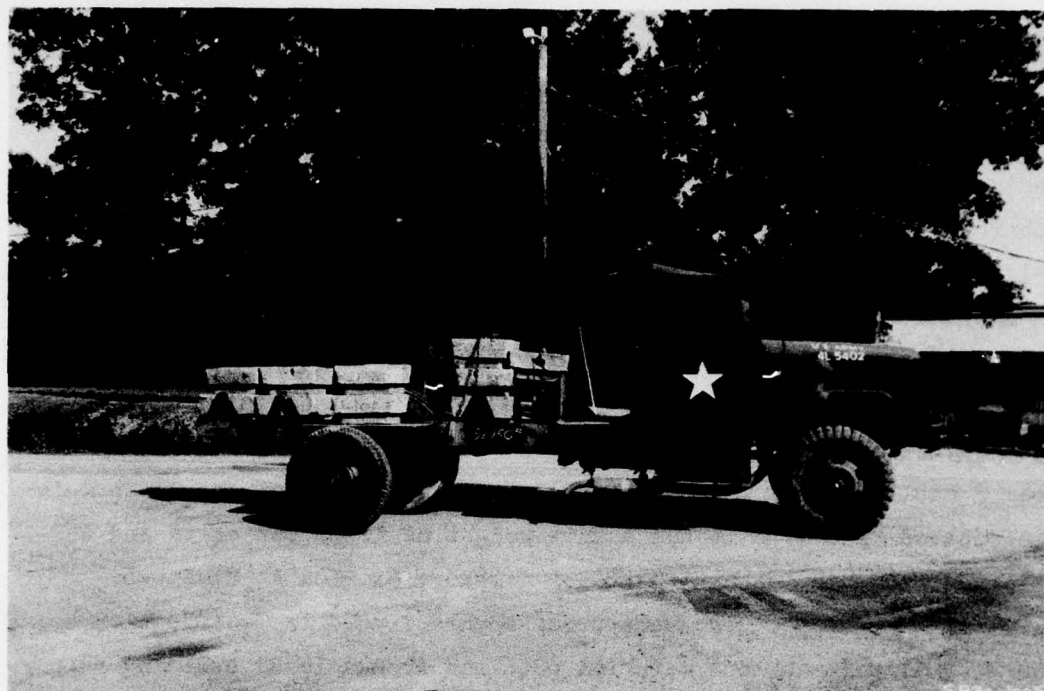
Figure 1. Thirty-five-kip single-wheel test cart

13. Two specially designed load carts were used in the application of traffic on the test sections. A single-wheel test cart (Figure 1) loaded to provide a single-wheel load of 35 kips was used to simulate the loading conditions of a C-130 aircraft for the traffic applied in Test Section No. 1 and the initial traffic in Test Section No. 2. For the final traffic in Test Section No. 2 and all simulated aircraft traffic in Test Sections Nos. 3, 4, and 5, a different load cart (Figure 2) was used. This latter cart was equipped with a single-tandem gear (one main gear of a C-130 aircraft) loaded to 70 kips. The load wheels of both carts were equipped with 20x20, 20-ply tires inflated to 100 psi.

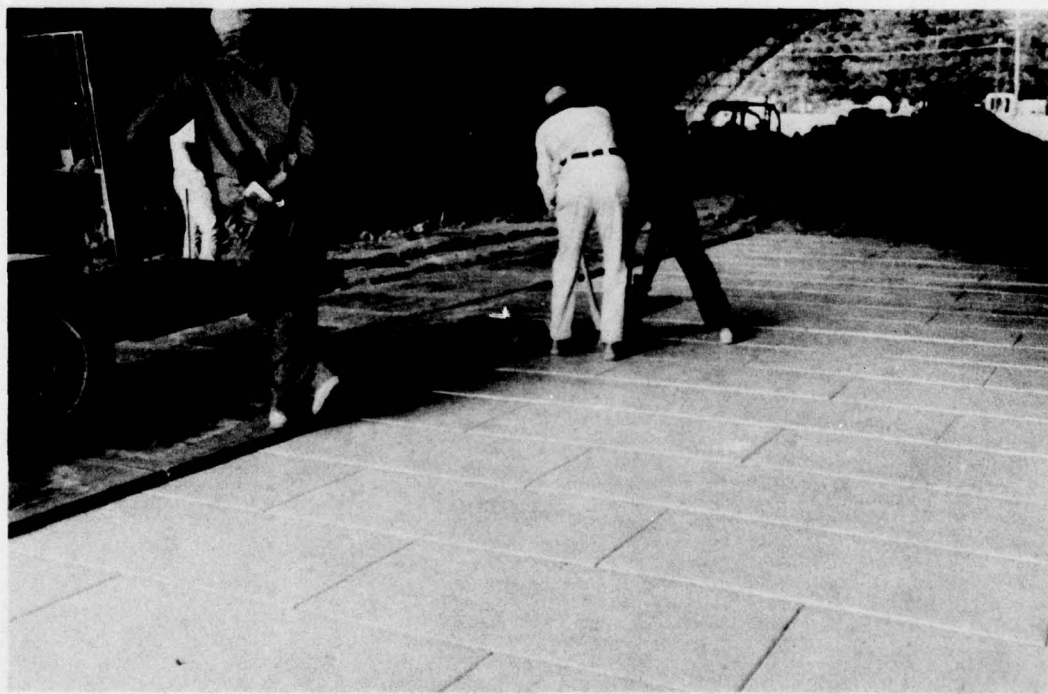
Photo 4. Placing XM19 landing mat over insulation

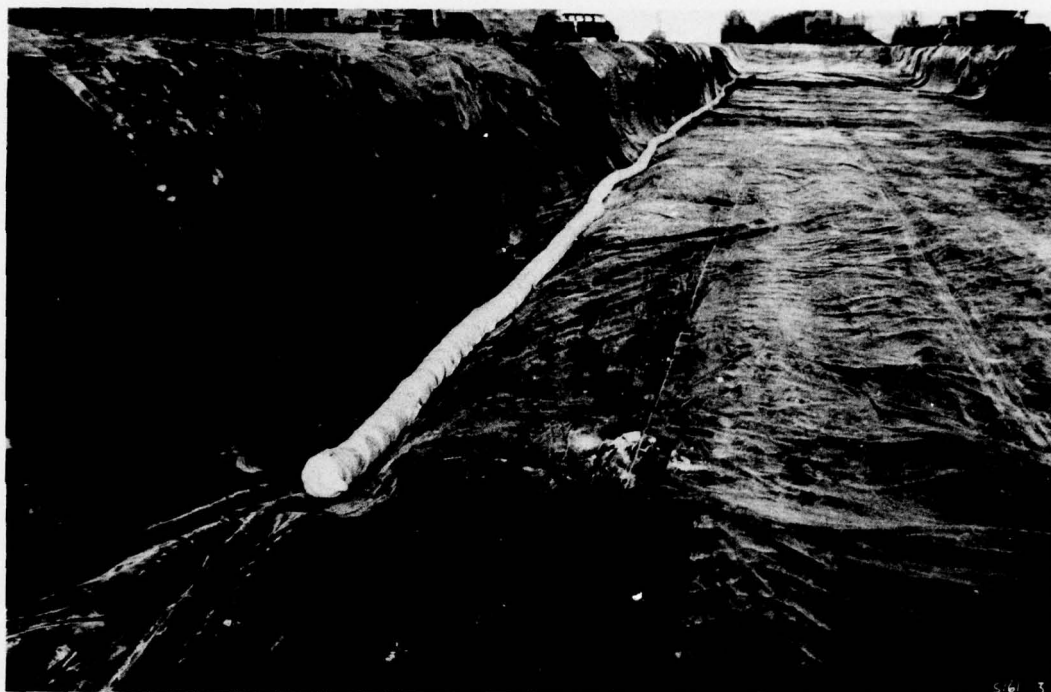
Photo 21. Membrane-lined Test Section No. 3 trench

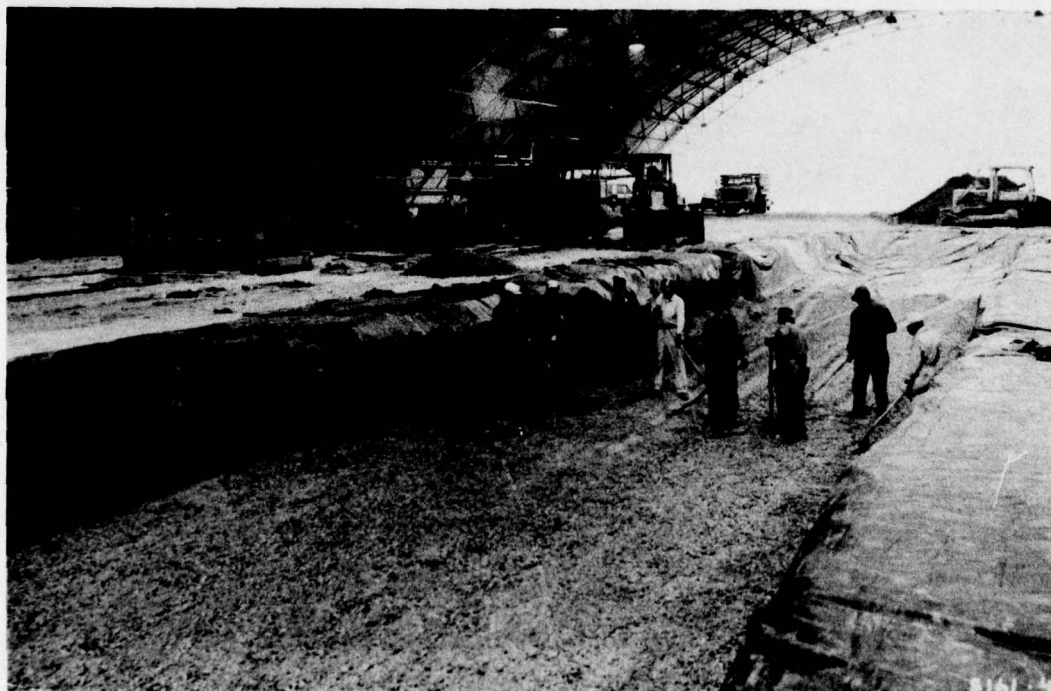
Photo 22. Hand leveling washed gravel

44. A test trench 25 ft wide by 160 ft long was excavated under hanger No. 4 at the WES (see layout, Plate 9). The depth of excavation was about 54 in. for test items 1 through 4 and about 15 in. for test item 5. The foundation soil at the bottom of the excavation was a lean clay material, which was leveled and compacted at the desired elevation. A trench approximately 1 ft wide and 6 in. deep was excavated at the bottom of the section along the west side of test items 1 through 4, where a 4-in.-diam perforated pipe was to be installed for later use in saturation of the sand fill. The bottom and sides of the test trench were then lined with a waterproof neoprene-coated nylon membrane. The perforated pipe was wrapped with a filter cloth and installed in the trench (Photo 21). A solid 4-in.-diam PVC pipe connecting to the perforated pipe was installed in a lateral trench with a slight slope to a sump (section B-B, Plate 9). The pipe was capped off at the sump. An open, vertical standpipe was installed for supplying water to the sand through the perforated pipe and gravel blanket after construction. A 6-in.-thick blanket of washed gravel was then placed over the waterproof membrane and around the perforated pipe in the bottom of the excavation (Photo 22). The washed gravel was then covered with a filter fabric (Photo 23).

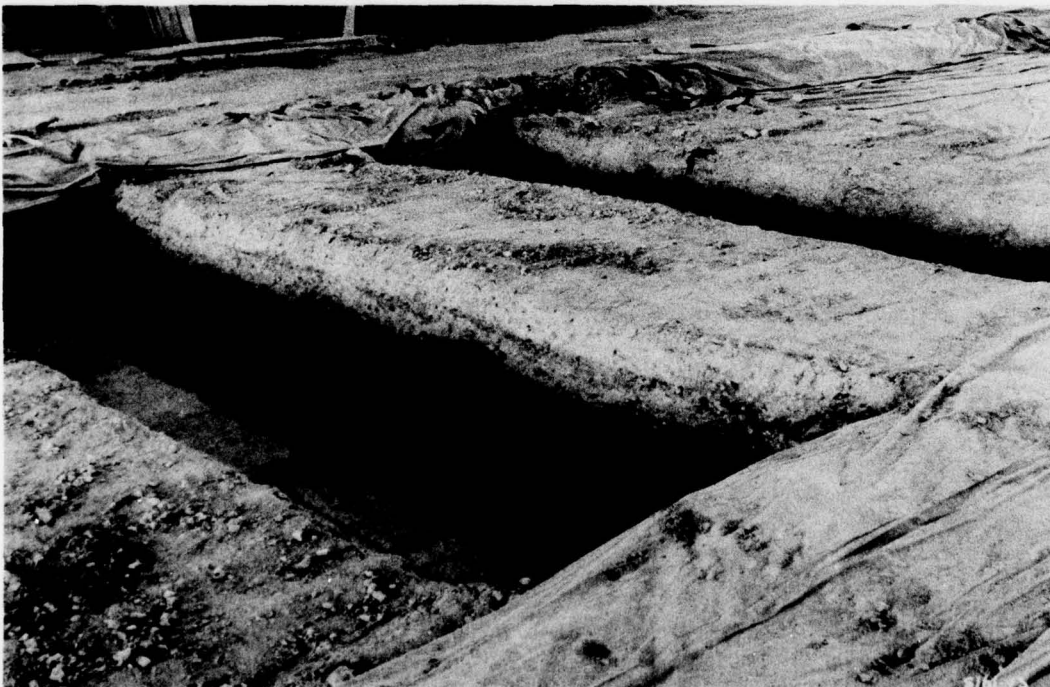
Photo 24. Eight-foot-wide trenches excavated in Test Section No. 3, item 4, to be backfilled with loose sand

pit-run sandy gravel, and the top 18 in. was stabilized with 6 percent portland cement. The gravel material was placed and then compacted in about 19-in.-thick compacted lifts over the entire 40-ft-long test item up to about 12 in. below final grade. After compaction of the stabilized base, two trenches 8 ft wide were excavated down to the surface of the filter fabric over the gravel blanket and the trenches were filled with loose uncompacted sand. Prior to placing the gravel, landing mats were placed over the filter fabric in the 8-ft-wide areas where the sandy gravel and mats would be later removed. The sandy gravel was then spread to the desired thickness and compacted with a pneumatic-tired roller. After construction of the high-strength base, the 8-ft-wide trenches were cut with a backhoe and the landing mat at the bottom of the trench was removed (Photo 24).

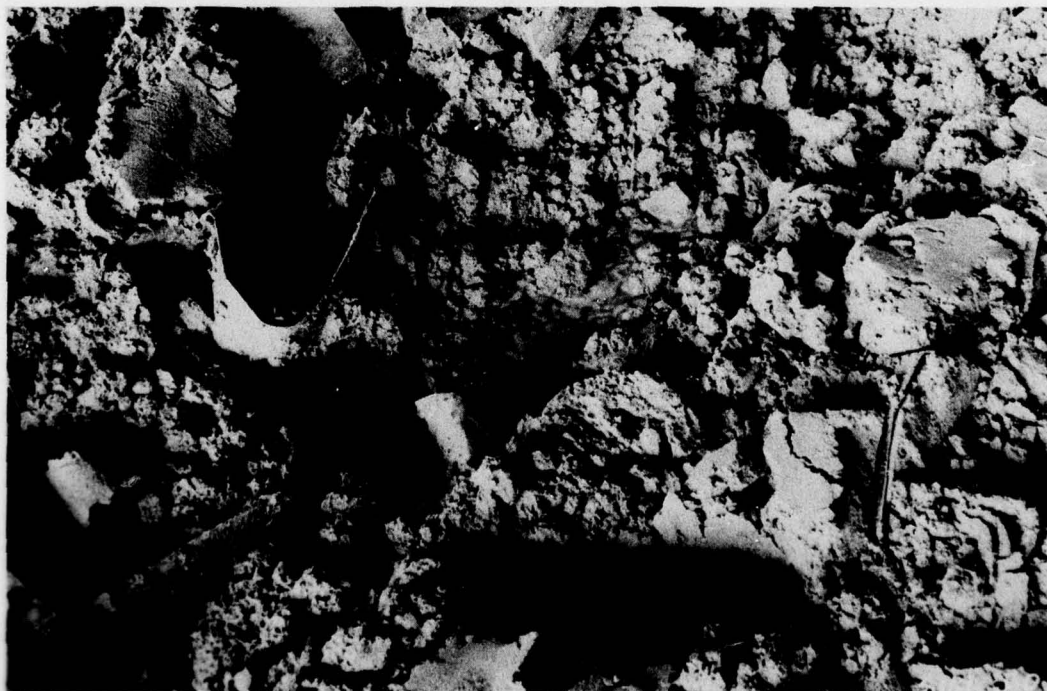
Photo 40. Closeup of damaged grid and water in ruts of Test Section No. 3, item 2

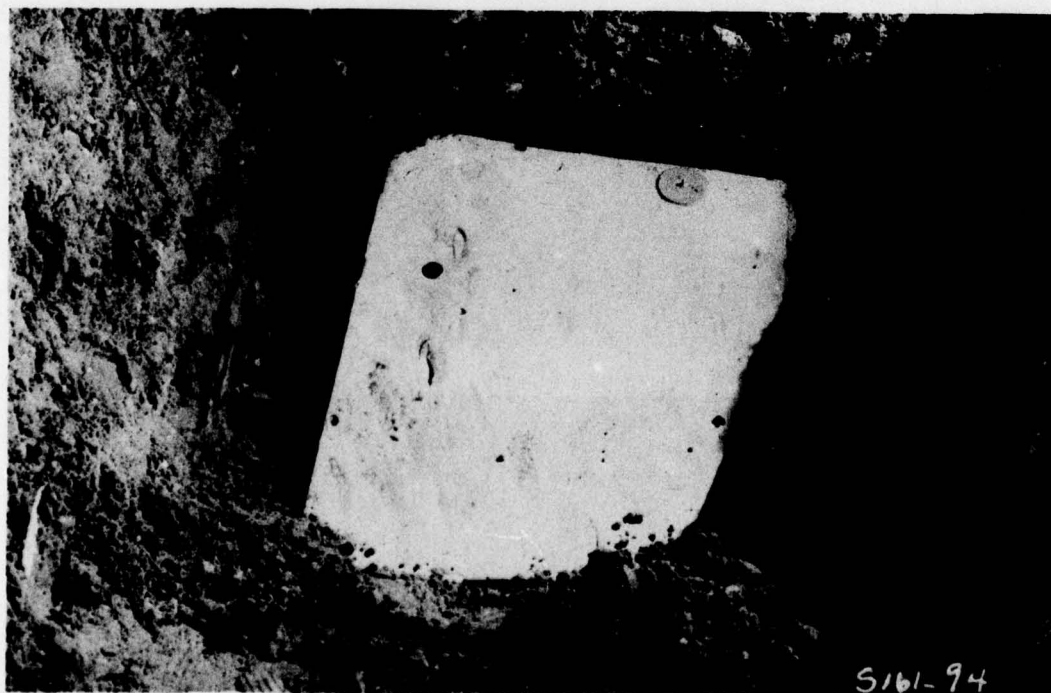
Photo 76. Difference in surface texture around gage in Test  
Section No. 4, item 1; gage protected by 1-in. cover of sand

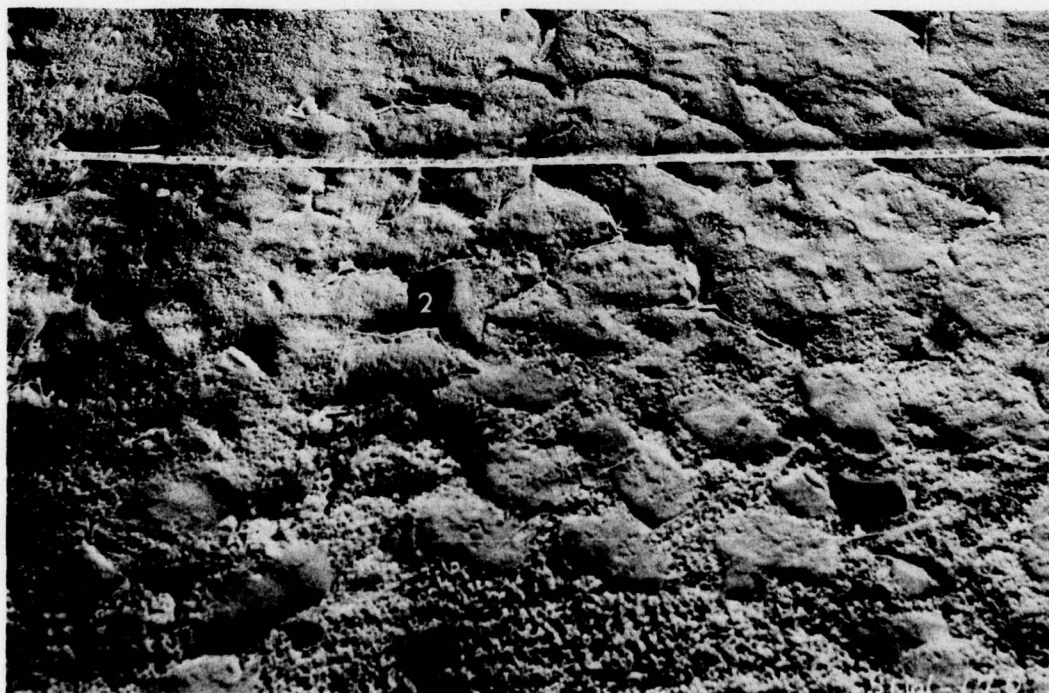
Photo 96. Top of 8- by 8- by 6-in. grid in Test Section No. 5, item 2
